Manhole Inspection Summary

Manhole # S33QQ_038MH

Insp Date: **3/23/07 11:34 AM**

Location Address: **2538 MACE ST**

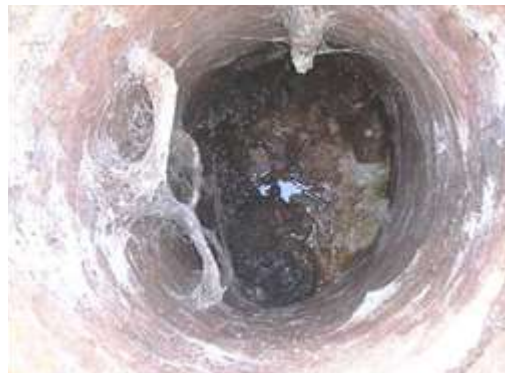
Top View

Adjustment, Corbel infiltration. Barrel root intrusion and infiltration. Corroded steps. Bench debris.

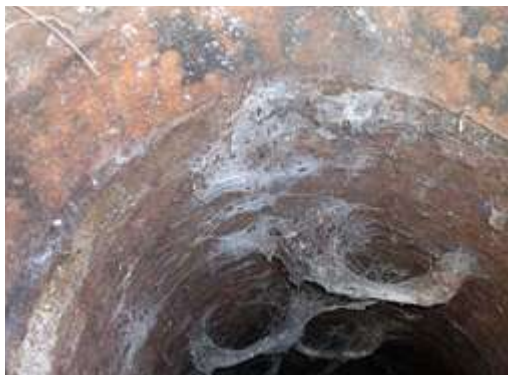
Defect

Adjustment, Corbel and Barrel infiltration - other side.

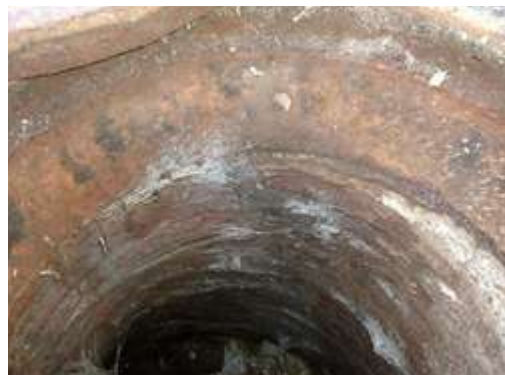
Defect

Adjustment, Corbel and Barrel infiltration.

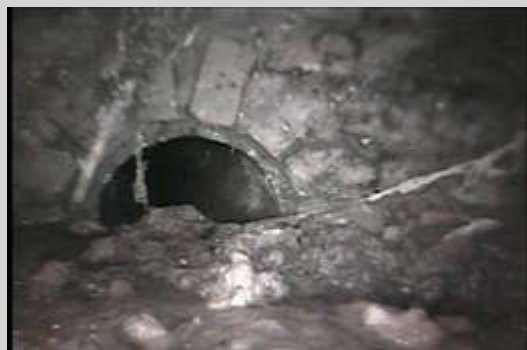
Pipe Out @ 12 O'Clock

Deposits: ☐ None ☒ **Mud** ☐ Sludge ☒ **Debris** ☐ Grease

Infiltration: **Evidence**

Pipe Seal Cond: **Roots**
